Cyclic Triaxial Testing on Undisturbed Samples of Rhyolitic Material from the Waikato Region.

Report Number: OG17-01

Prepared by: Mark Stringer, University of Canterbury

Date: 5th April 2018

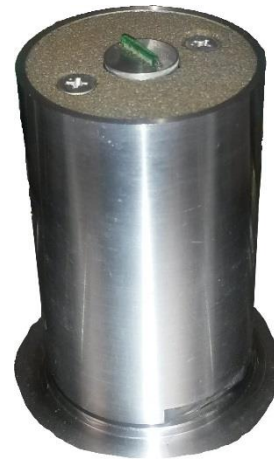
(b) Bender element platen

Figure 4: Bender element set-up

Shear wave velocity testing was carried out on specimens which had been trimmed to 50mm diameter using bender elements. When carrying out these tests, a sinusoid voltage pulse is sent to the “source” bender element (mounted in a platen as shown in Figure 4b), which deflects under the voltage applied. This generates a horizontally orientated shear wave to propagate vertically through the specimen. When the shear wave arrives at the “receiver” bender element, it causes a small deflection of the bender element, which in turn generates a small voltage, which is monitored using an oscilloscope. This system is shown schematically in Figure 4(a), along with a photo of one of the bender elements used in the Seiken triaxial device. By considering the height of the specimen and the time difference between sending the voltage pulse and the first arrival of the shear wave, it is possible to estimate the shear wave velocity (Equation 3, where l_{tt} is the distance between the tips of the bender elements). It should be noted that the source wave is not directly measured, but is assumed to be the same shape and occur at the same time as the output from the signal generator. In practice, there is a delay between the output of the signal generator and the displacement of the source bender element. The “system delay” is measured by holding the tips of the source and receiver elements together and measuring the time lag between the source signal and the received signal. For the testing presented in this report, the time delay is 11.1 μ s. This time delay was subtracted from the receiver signal prior to picking the arrival time.

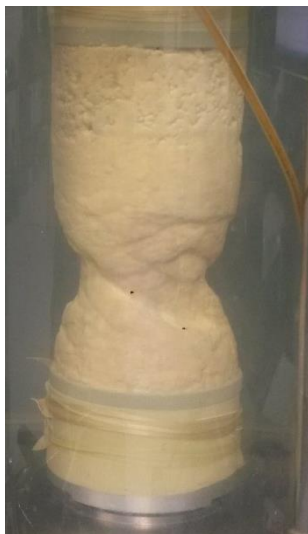
(a) Necking of specimen AP12a-DM1-4-A

Figure 10: Post-failure appearance of specimens

Axial strains developed mainly on the extensional side of loading. This has been observed in a number of studies on undisturbed samples. However, an important feature of the strain development is that the specimens typically failed in a brittle manner once the level of axial strain reached 2-3%. Clear failure planes were observed during the testing (Figure 10 shows 2 examples), and in many cases caused extreme necking of the specimen (usually towards the middle of the specimen, as shown in Figure 10a). In the case of specimen AP12a-DM1-6C (Figure 10b), the failure caused a leak in the membrane, and the test was halted at that stage. When the specimen was removed from the apparatus, it was apparent that it had split into two distinct halves, with the failure plane at a relatively shallow angle to the horizontal (i.e. not on the plane of maximum shear stress). These behaviours suggest that in the cyclic tests, there were pre-existing defects (either cracks, or as a result of the assumed double porosity), which promoted brittle on the near-horizontal plane.

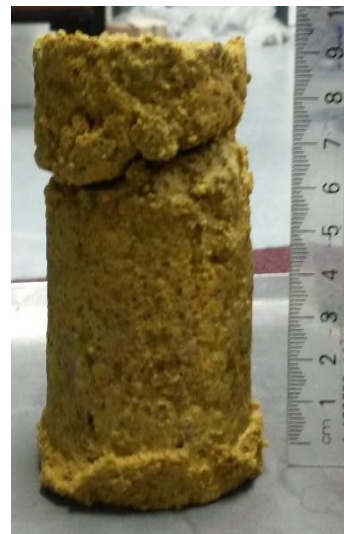
(b) Failure plane on specimen AP12a-DM1-6-C
